STABILITY ANALYSIS NEAR KANSAS CITY, MO

- Historic single-level limestone operation
- Scope of Work:
 - / Determine the stability of the general area
 - / Identify alternatives for a remediation plan to allow for construction of commercial structures on site

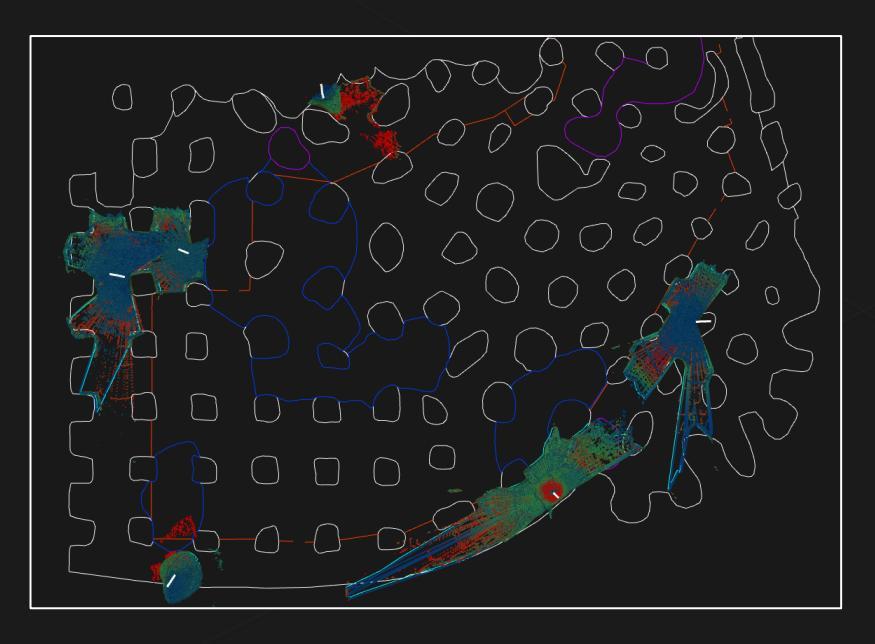
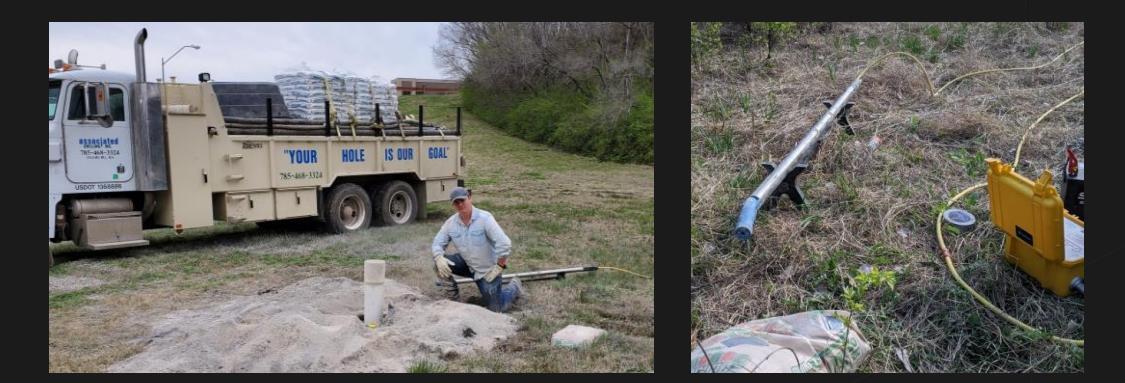
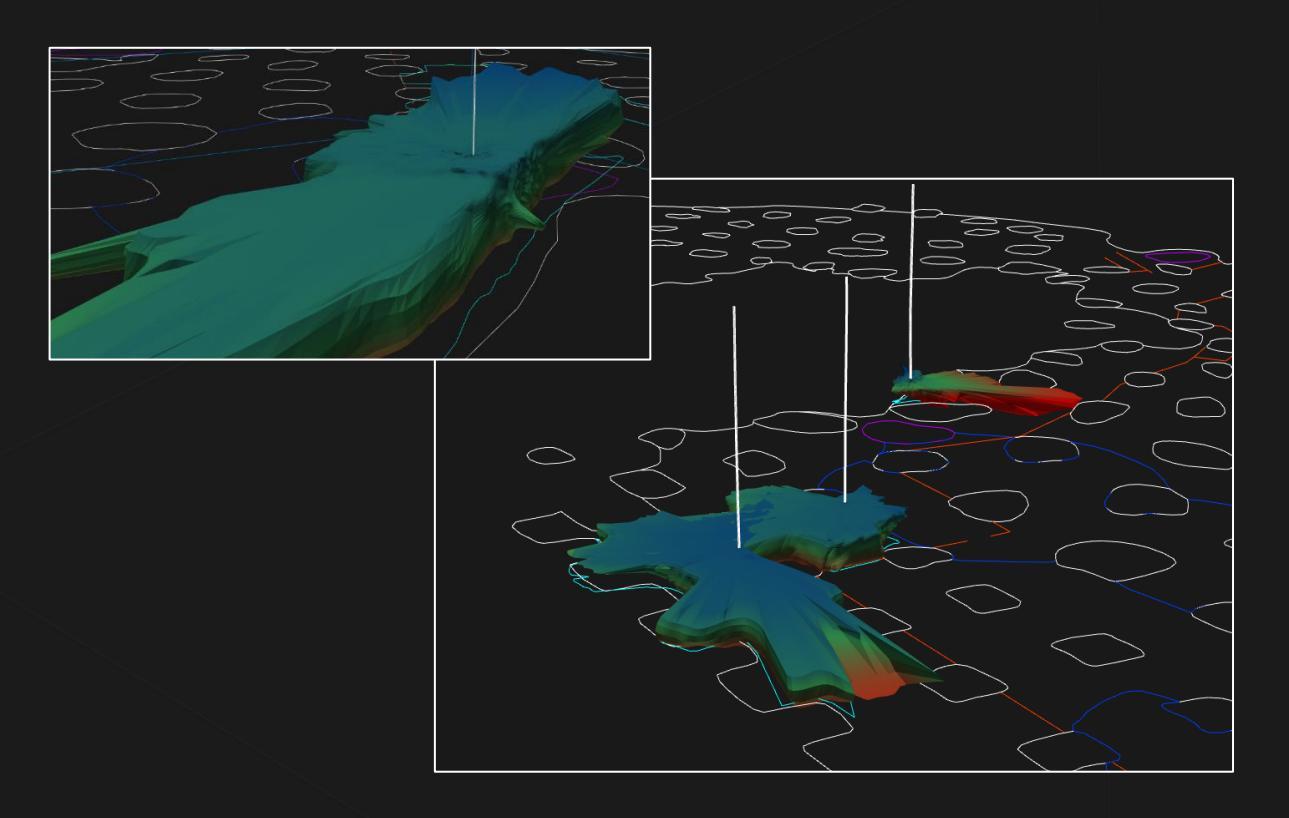
Remote Scan and Mine Map Correction

- / Drilled 13 Holes
- / Surveyed 15 Holes
- / Geolocate and update maps with scans
 - » Plan view
 - » Elevation adjustment

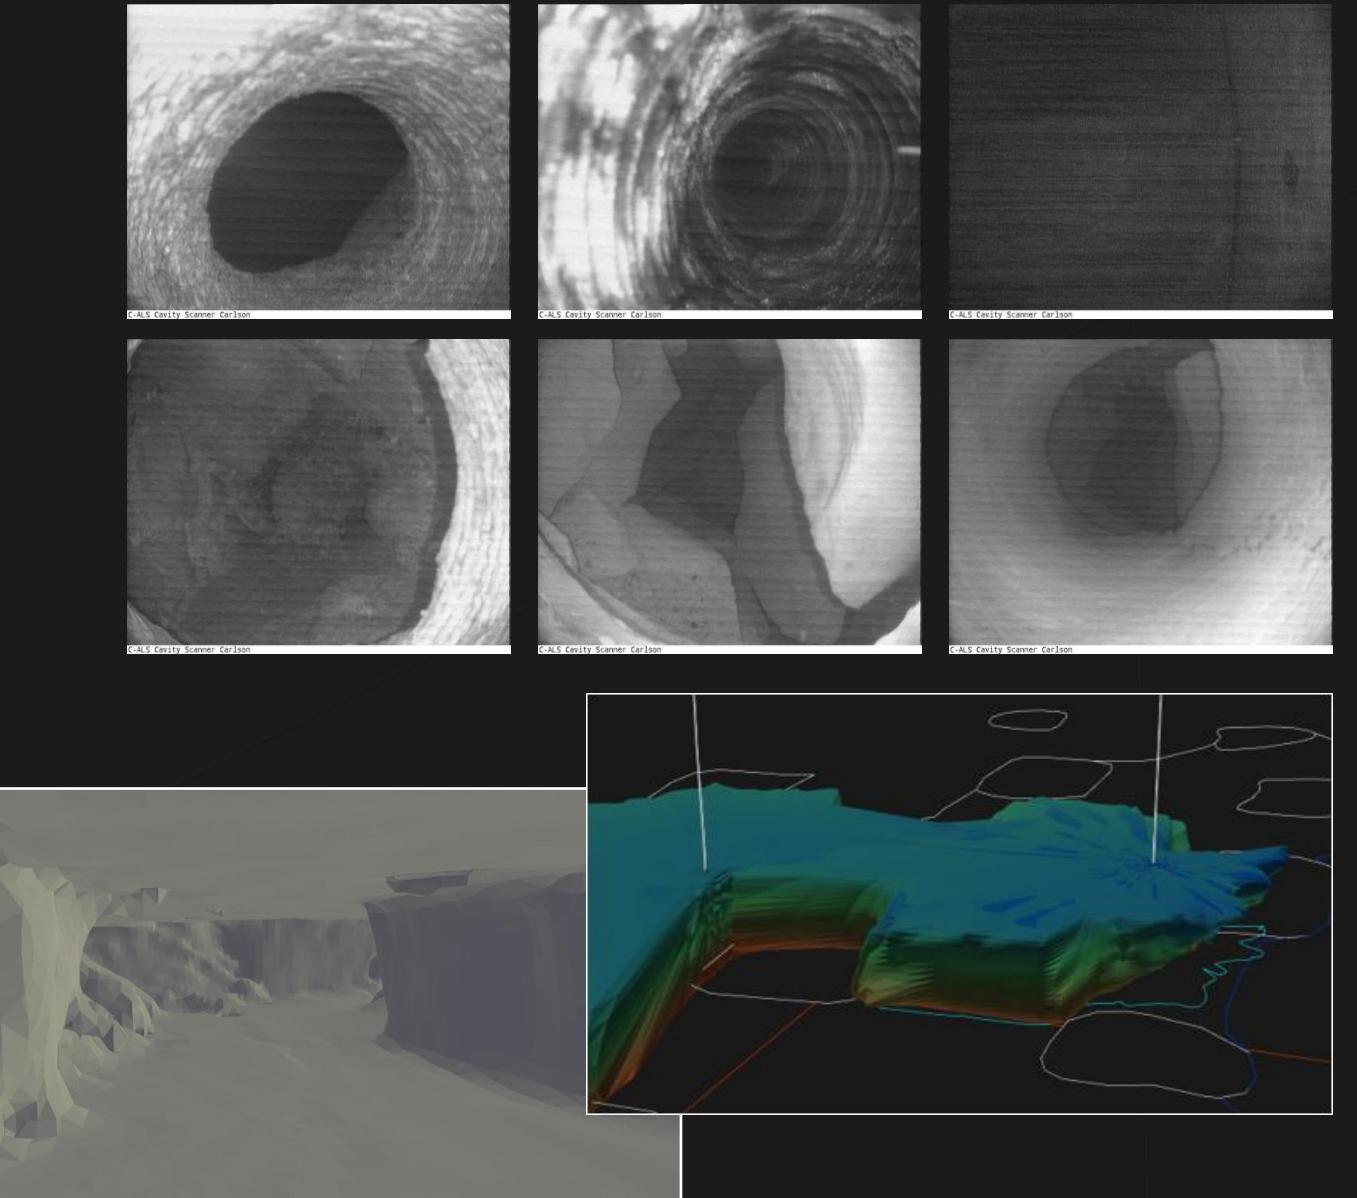
Review of Mine Extents and Collapse:

- / Confirm drill logs
- / Photos of geological, hole, and working conditions
 - » Identify roof support and utilities underground
- Mapping information geotechnical analysis
 - Approximate depth of geological inconsistencies
 - » Pillar dimensions and integrity
 - » Roof conditions
 - Stable and collapsed areas

Surface Investigation

» Sinkholes

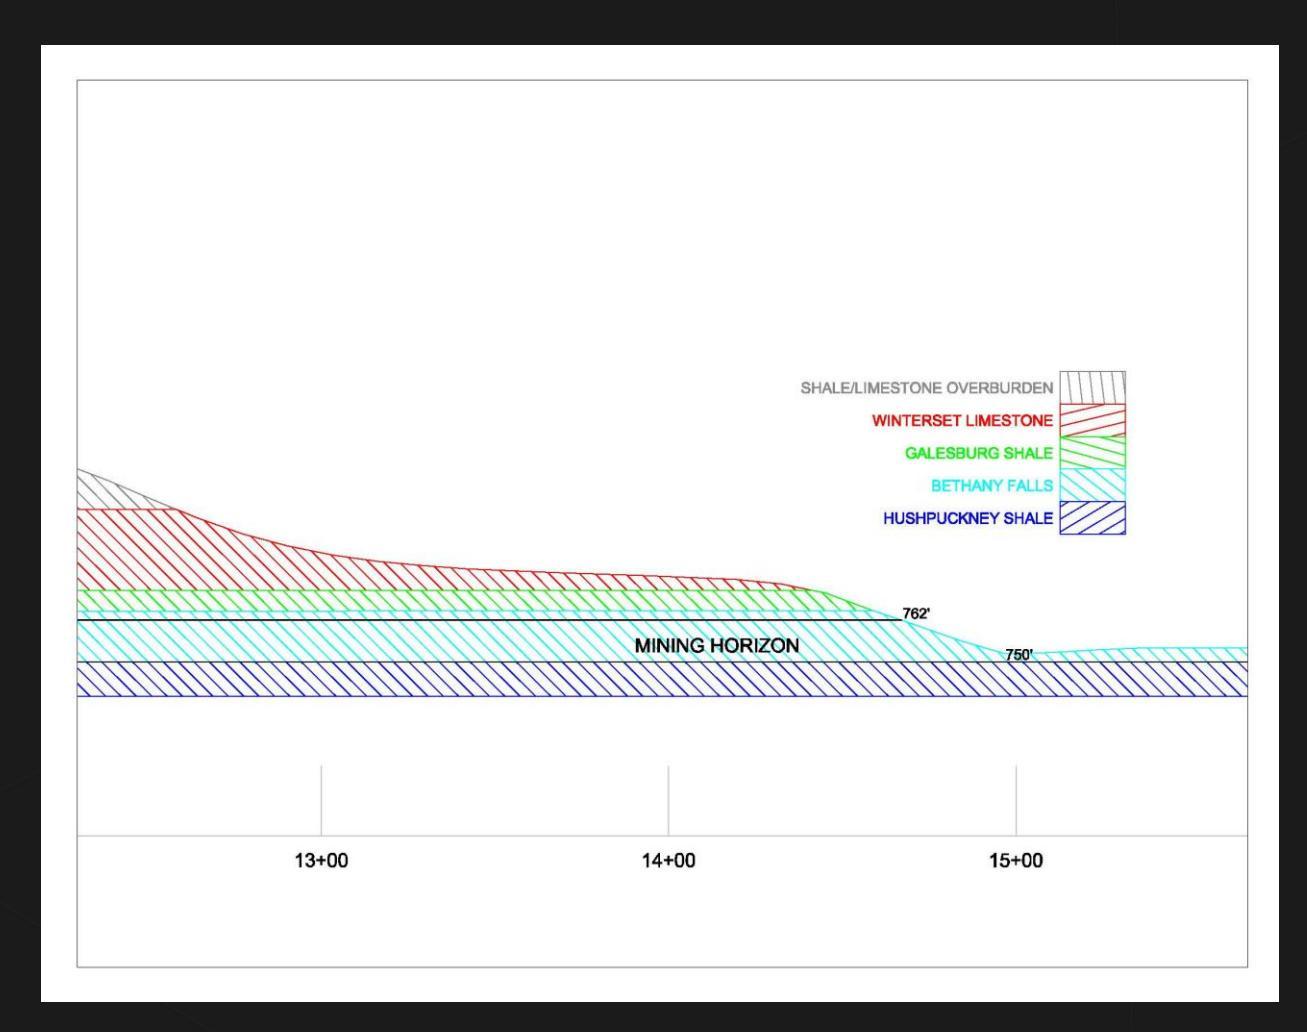
- Review of Mine Extents and Collapse:
 - / Collapse extent determined using BF and size of historic workings
 - / Volumetric analysis separated into 4 horizons

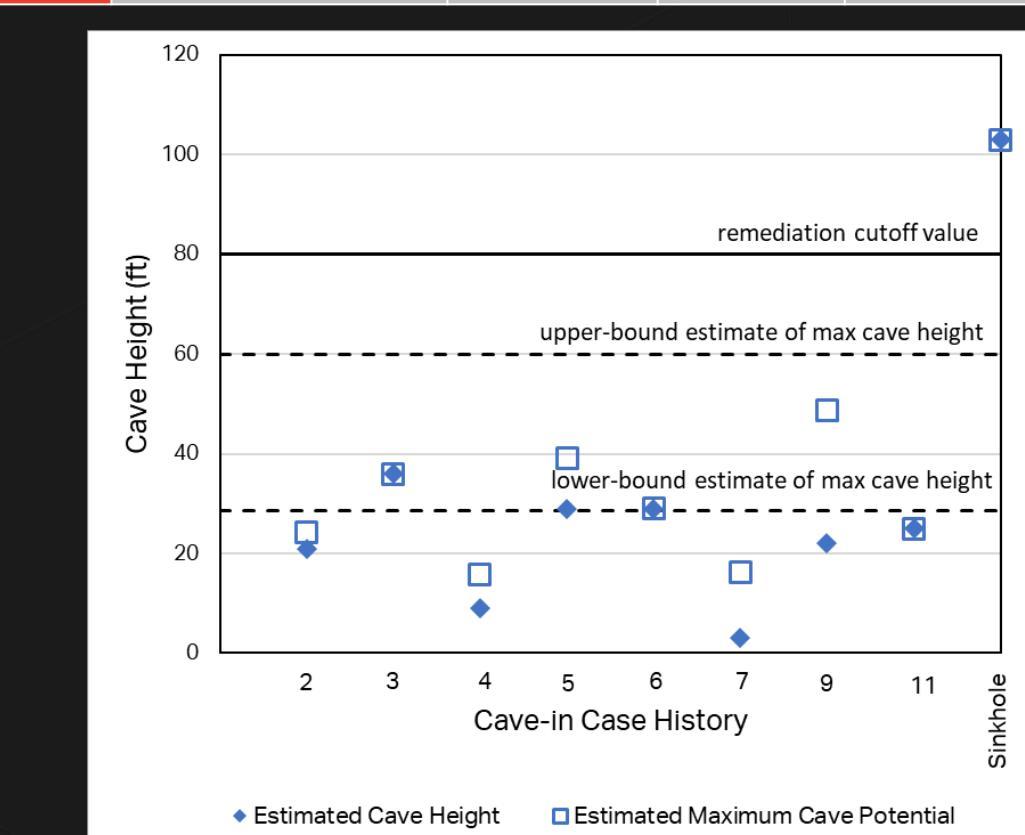
Roof Collapse Review:

- / Reviewed all holes with caving above designed roof height
 - » 8 of 15 holes investigated
- / Estimated Bulking Factor (BF)
 - » Range of cave height using an assumed floor elevation based on scan data
- Collapse potential calculated based on remaining void and a conservative BF of 1.3
- / Sinkhole is an outlier most likely related to local geology

No. of Cases	Мах	Min	Average
Cave Height Above Roof (ft)	8	29 - 36	3 - 9	20 - 22
Cave Distance Into Winterset (ft)	5	23	3	14
Cave to Top of Winterset	1	CH3, 75-ft Unsupported Span		
Cave Above Winterset	1	Sinkho	ole, Cave to Sur	face
BulkingFactor	8	1.52 – 1.93	1.18 – 1.25	1.45 – 1.57

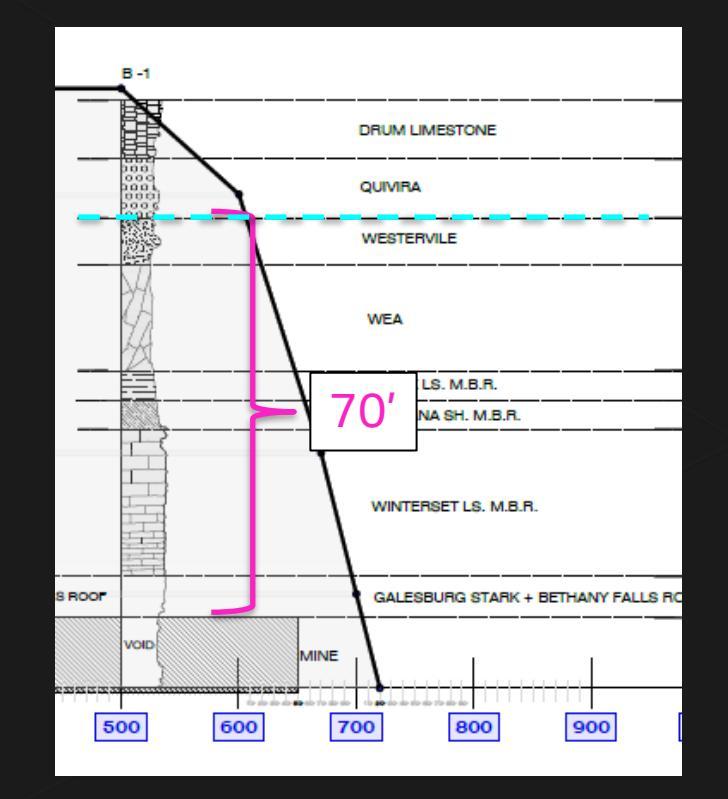
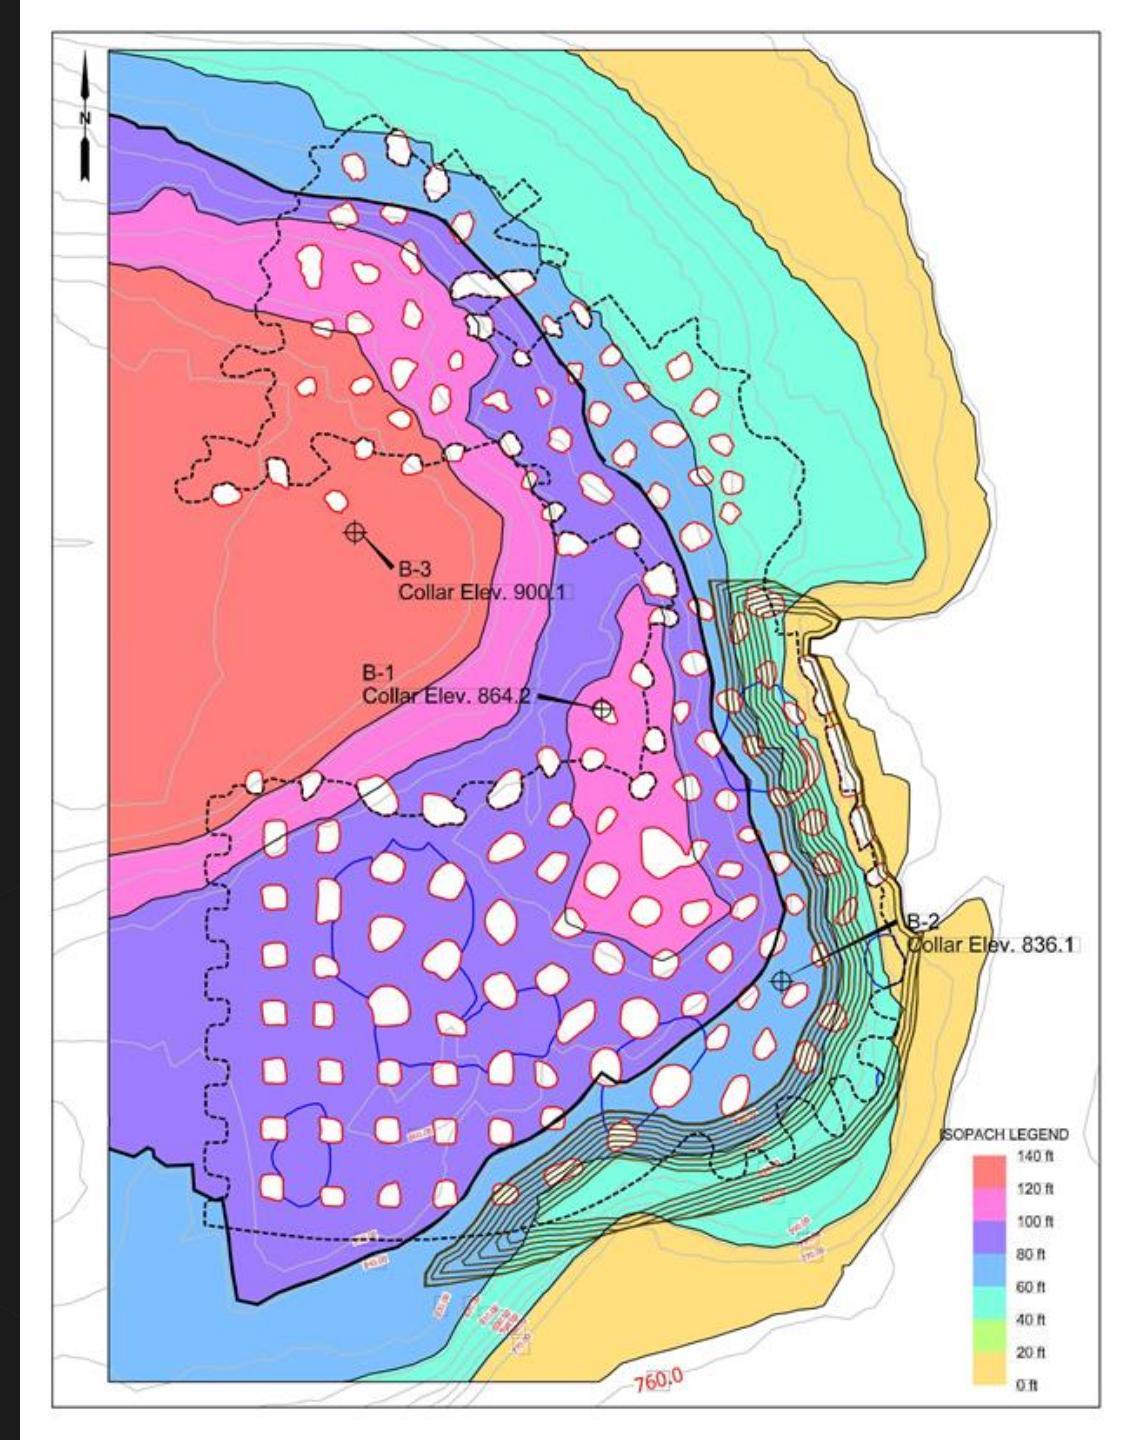
Reclamation Requirements and Limitations

70 ft cover requirement

Anything less will need to be excavated and back filled
70 ft to 80 ft will require grout columns

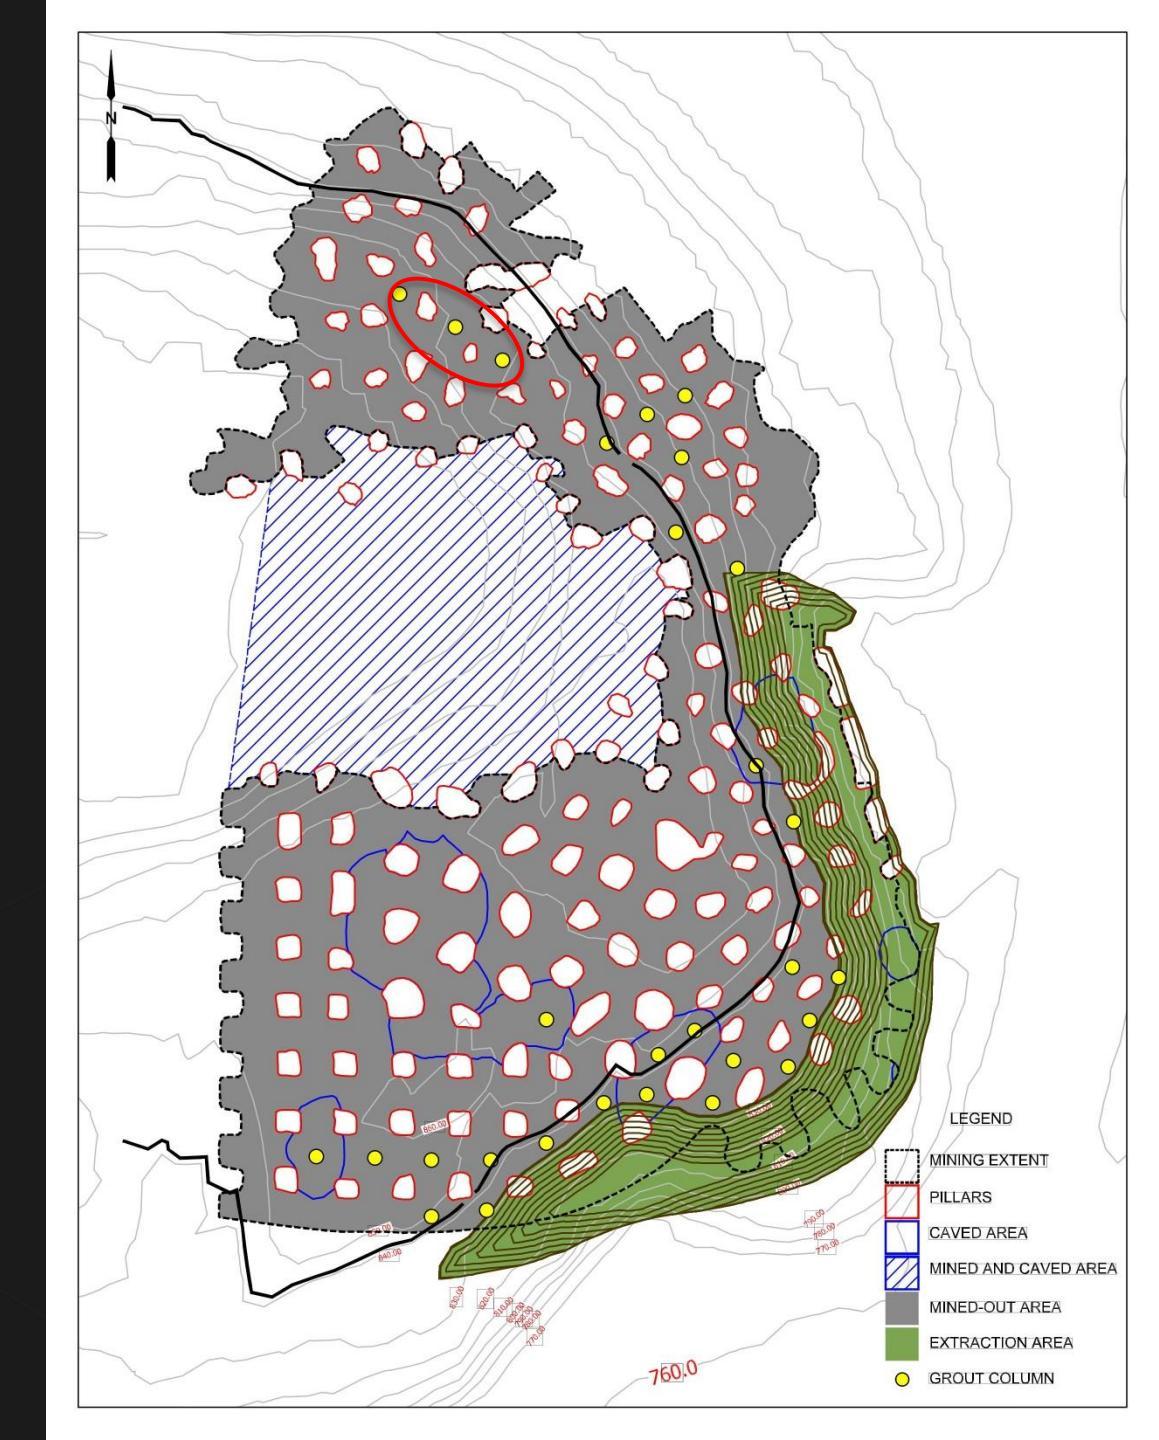
- Recommended Approach for Site Development
 - Prepare site for commercial construction
 - / Shallow cover extraction with grout columns
 - / Backfill with material on-site
 - » Regrade and put in roads as needed
 - / Work possible year-round with consideration of the effects of wet and cold weather
 - / Provided estimated cost summary

Extraction Area Volumetric Analysis					
		Volume	Avg. Thickness		
Horizon	Strata	(CY)	(ft)		
Overburden	Shale/Limestone	38,000	21		
	Winterset Limestone	43,800	23		
	Galesburg Shale	10,700	6		
	Bethany Falls	7,200	4		
	Sub-Total	99, 700	53		
Remaining Pillars	Bethany Falls	1,800	12		
Extraction Total		101,500	65
